Manhole Inspection Summary

Manhole # S65M__009MH

Insp Date: **5/14/08 12:30 PM**

Location Address: **6201 O'Donnell St.**

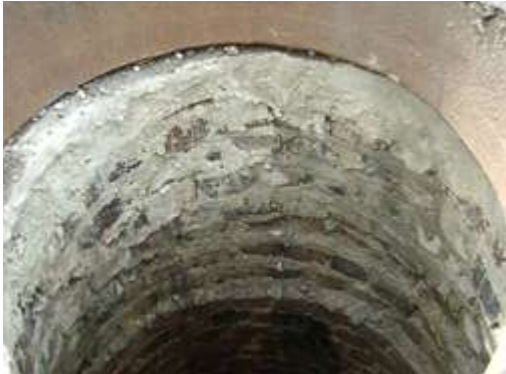
Defect 2

gap under frame

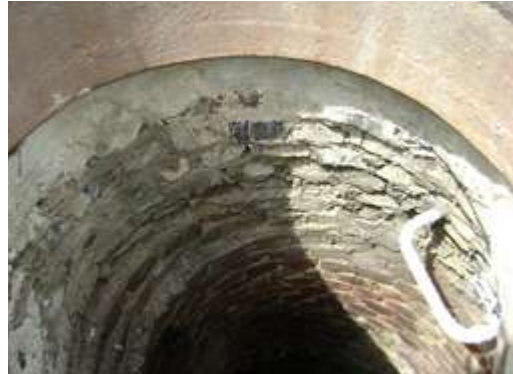
Defect 3

Condition: ☐ Sound ☐ Cracked ☐ Root Intrusion ☒ Loose Brick ☒ Deteriorated

Infiltration: ☐ None ☒ Joint ☐ Cracks ☒ Mortar ☐ Roots ☐ Wall

prior repair in frame adjustment

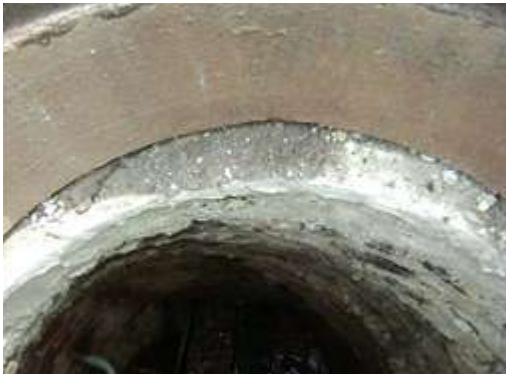
Defect 1

Frame Offset: **2** (in.) Condition: ☒ Sound ☐ Cracked ☐ Leaks

frame offset

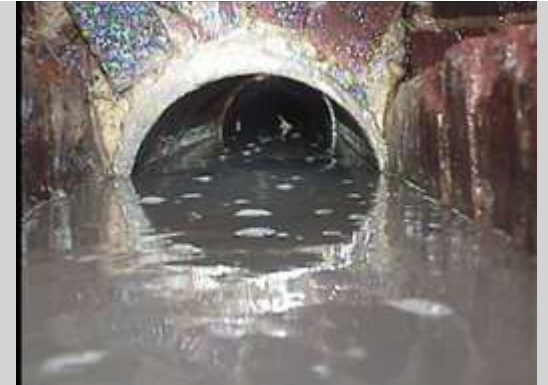
12 O'Clock Outflow

8 in. Circular Gravity Sewer
Pipe Out @ 12 O'Clock

Pipe Height: **8.4** (in.) Rod and Bar (Angled)
Pipe Material: **Clay** ☐ Pipe Lined
Invert Depth: **11.08** (ft.) Flow Characteristics: **Slow**
Deposits: ☐ None ☐ Mud ☒ **Sludge** ☐ Debris ☐ Grease
Silt Depth: **0.5** (in.) Deposits Extent: **Light**
Infiltration: **None** Pipe Seal Cond: **Sound**

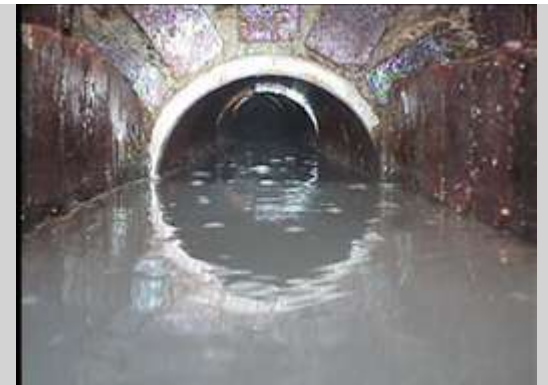
6 O'Clock Inflow

8 in. Circular Gravity Sewer
Pipe In @ 6 O'Clock

Pipe Height: **8.4** (in.) Rod and Bar (Angled)
Pipe Material: **Clay** ☐ Pipe Lined
Invert Depth: **10.92** (ft.) Flow Characteristics: **Slow**
Deposits: ☐ None ☐ Mud ☒ **Sludge** ☐ Debris ☐ Grease
Silt Depth: **0.5** (in.) Deposits Extent: **Light**
Infiltration: **None** Pipe Seal Cond: **Sound**
